**Wootton Bridge & Whippingham**

# **Walking & Cycling Environment Report**

**June 2018**

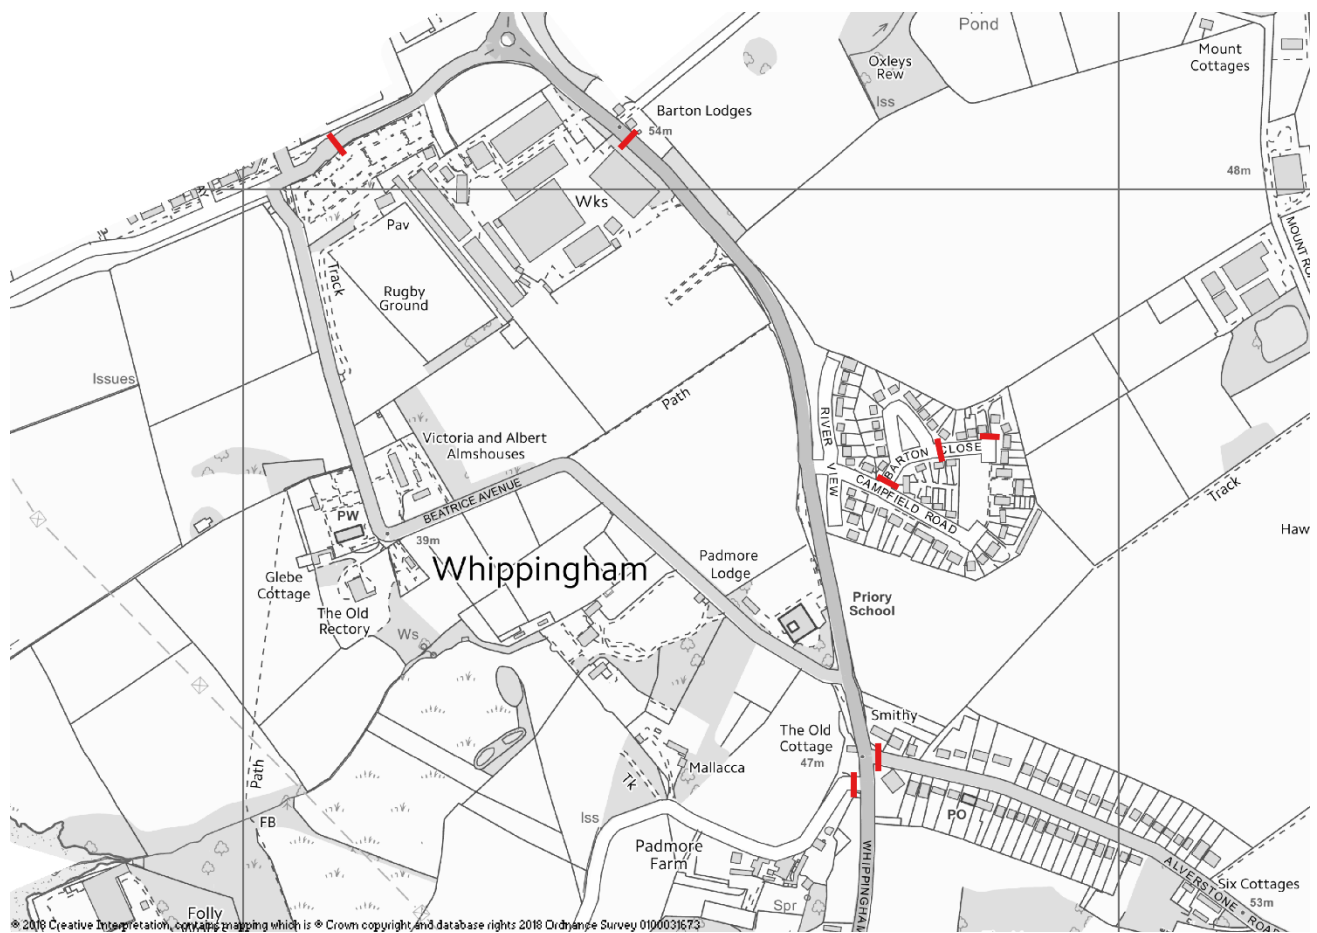
Figure 2 - Missing Crossings (Whippingham)

In many streets formal crossing points (either controlled or uncontrolled) are completely absent, while in other streets they are not provided frequently or consistently enough. At junctions it is important for all arms of the junction to have crossings (typically an uncontrolled crossing except at major junctions) to maximise choice of direction. Where crossings are provided they are often of a poor standard, with a variety of issues including inadequate width, excessive gradient or crossfall, missing or incorrect tactile paving and non-flush kerbs. Locations which do not have a formal crossing but appear to need one are shown in figures 2 and 3. A list and maps showing all the crossing surveyed is contained in Appendix 3.

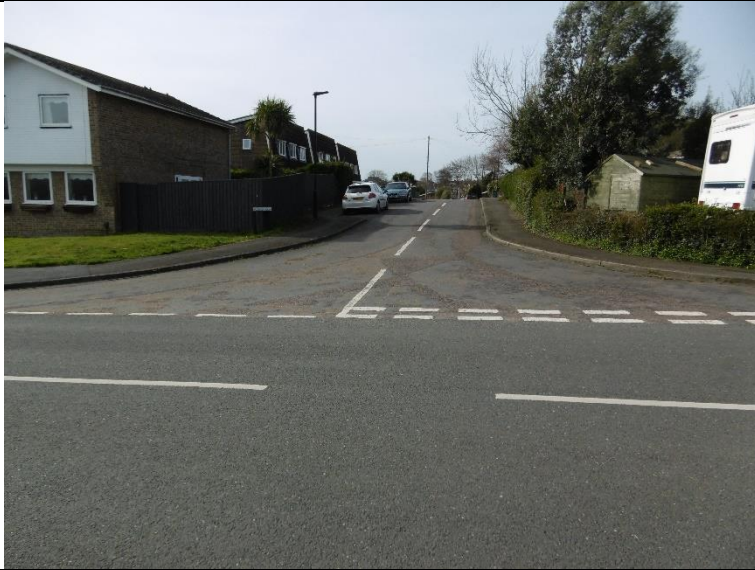
### Junction of St Edmunds Walk/Woodlands Crescent

Many of the junctions in this area are configured like this, with wide junction mouths providing long levels of exposure for people walking and cycling. Vehicles can turn excessively fast for the nature of the streets. The street is purely residential in nature so access for large vehicles is rarely needed. No formal crossing is provided.

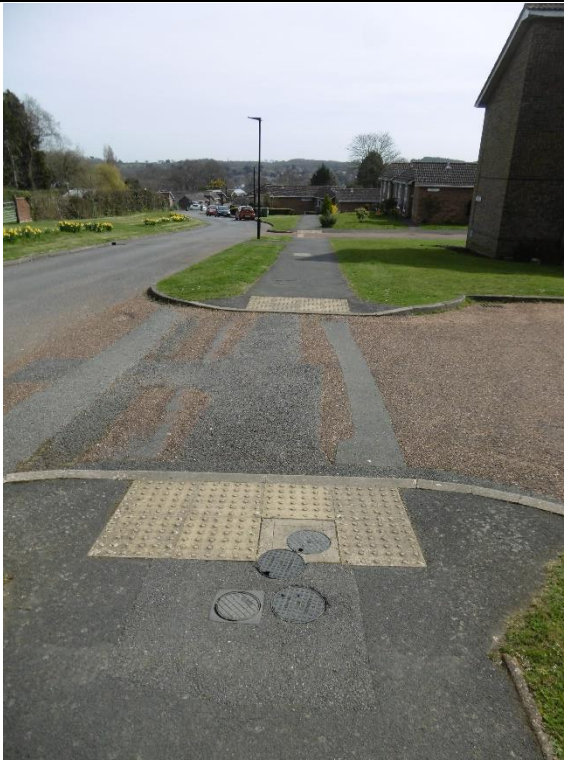
### Church Close

Here two minor car park entrances in quick succession are prioritised over pedestrians, who have an undulating footway which is particularly problematic for people with mobility issues.

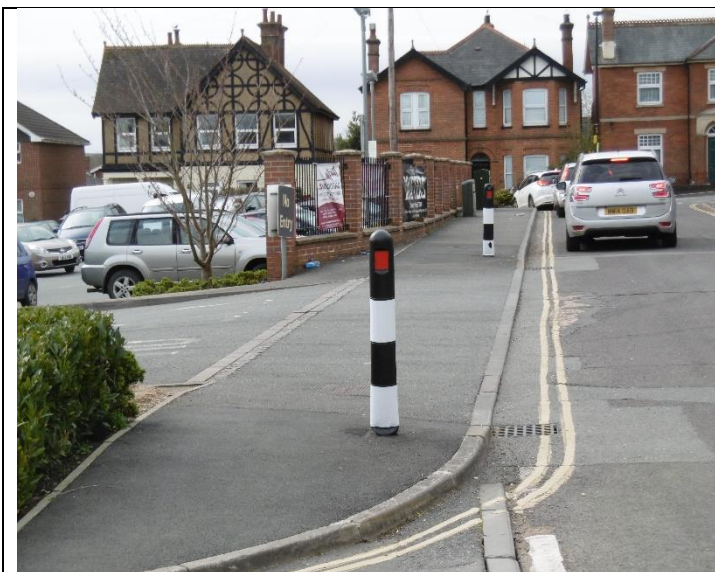
### Rectory Drive

These two bollards appear to have been installed to prevent vehicles overrunning the exit from Tesco. This exit is already very wide and we would question their necessity. They intrude into the footway providing a pedestrian collision risk and reducing available width. They should be removed unless there is a strong rationale for retention.

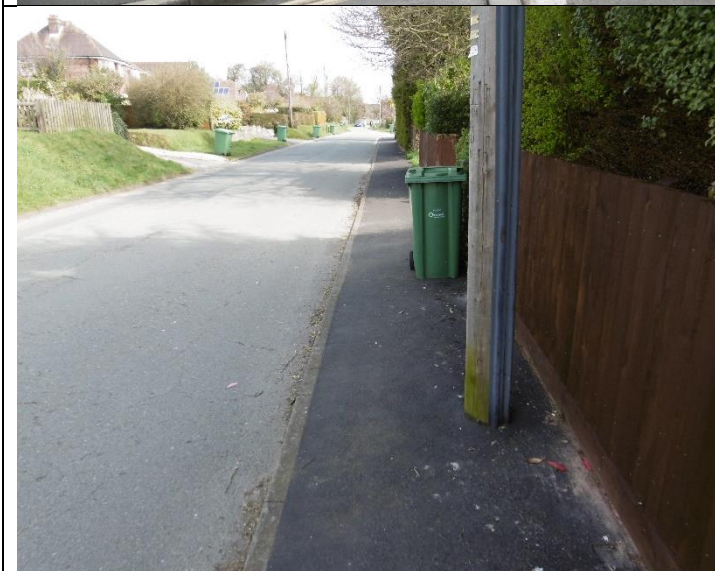
### Church Road

Telegraph pole narrows footway to 0.8m leaving inadequate width for a wheelchair user. Localised footway widening may provide an easier solution than relocation of the pole.

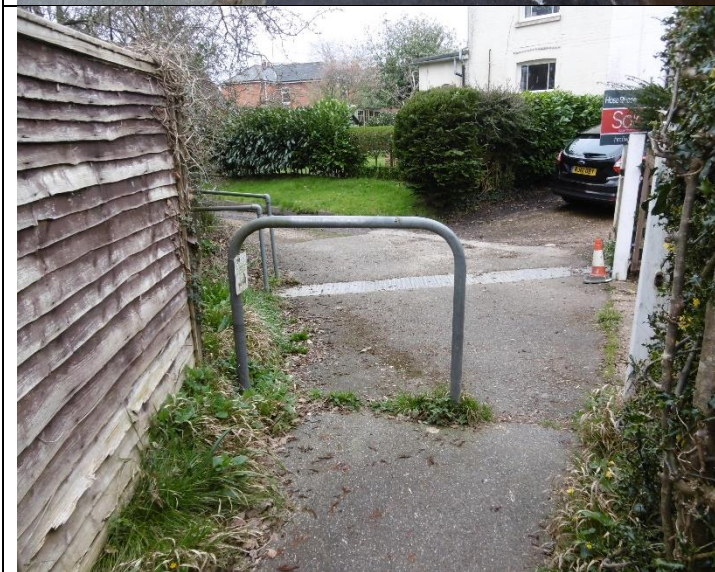
### Public Footpath N79

This barrier leaves only a 0.8m gap which is likely to completely prevent wheelchair access. Ideally the barrier should be removed, at very least it should be modified to provide wheelchair access. Upgrades to the rest of the footpath would improve its usability as a utility route.

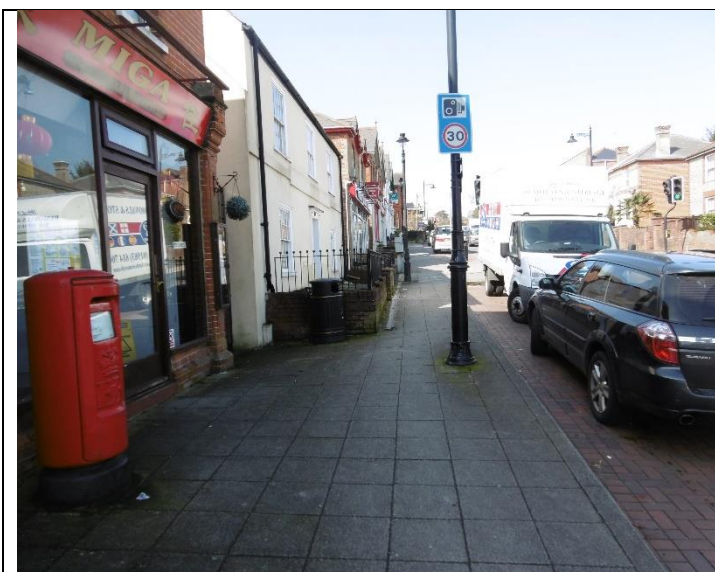
### High Street

This lamppost is in the main pedestrian flow. Ideally it should be relocated to the back of the footway.

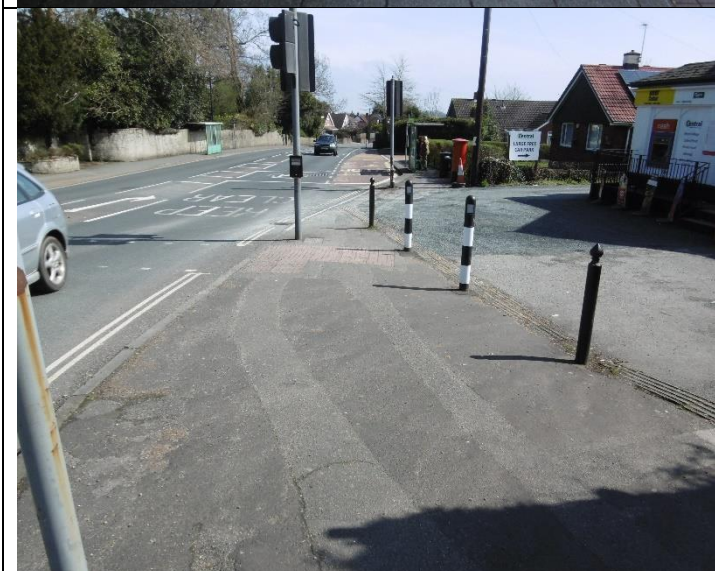
### High Street

The last bollard in this row is in line with the crossing and makes movements around the crossing area unnecessarily difficult. This bollard could probably be removed with no ill effects.

The use of bollards here does little for the look and feel of the area. An alternative solution would be some planting along the edge of the forecourt area in raised beds or similar to prevent vehicle encroachment onto the footway. This would improve the area aesthetically and provide the same function as the bollards do now. Alternatively, the business owners could choose to remove all parking to the front of the shop and create a more attractive space for customers with planting and seating.

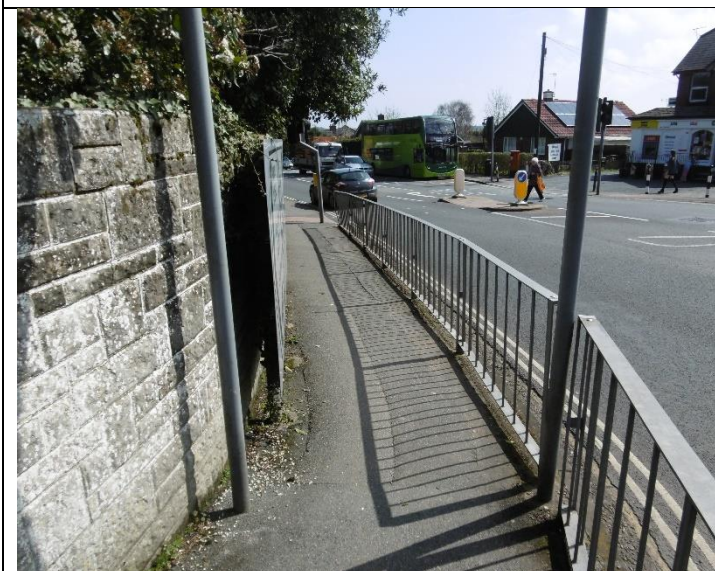
### High Street

Street furniture narrows this section of footway to 1.3m at points. The whole length is narrow and feels enclosed by the wall and guardrail. This corner could be remodelled to widen the footway, allowing the guardrail to be removed while still allowing sufficient space for traffic movements.

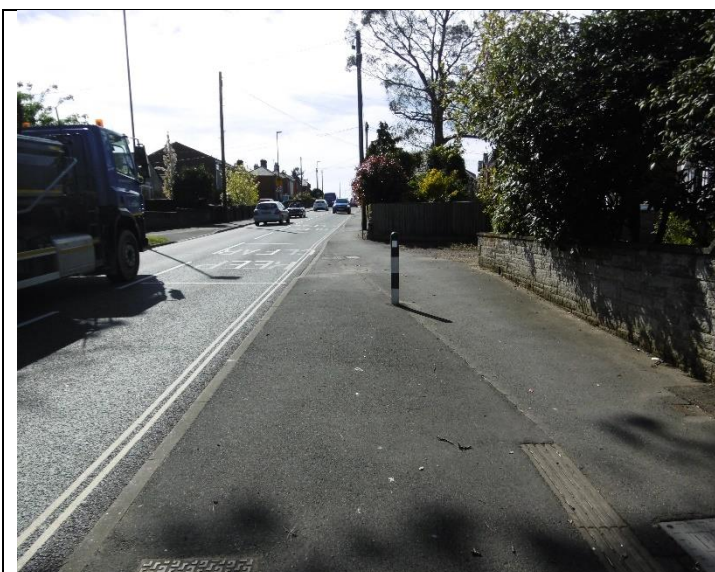
#### High Street

The rationale behind this bollard is unclear. It would appear that it could be removed, however if there is an overriding rationale for retention then it should be relocated so it is not in the centre of the footway.

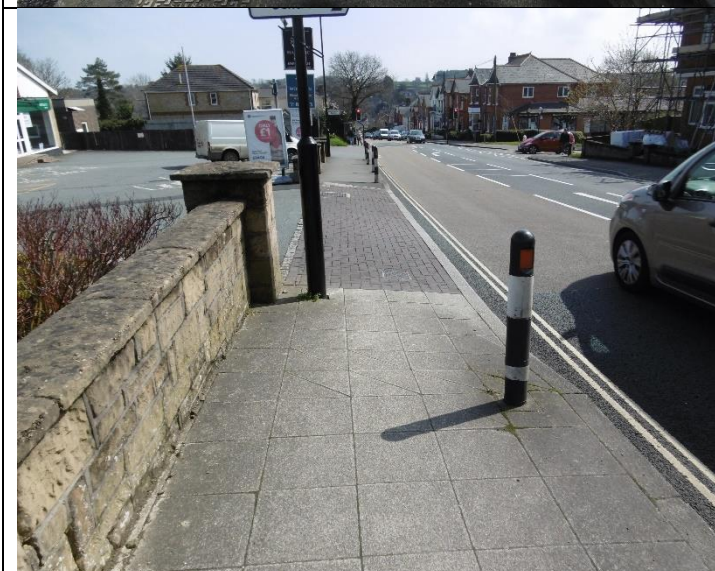
#### High Street

This bollard creates a pinch point with the streetlamp diagonally opposite. Its purpose is unclear as overrun would appear unlikely here and it offers no protection against footway parking. It should be removed unless there is a strong rationale for retention.

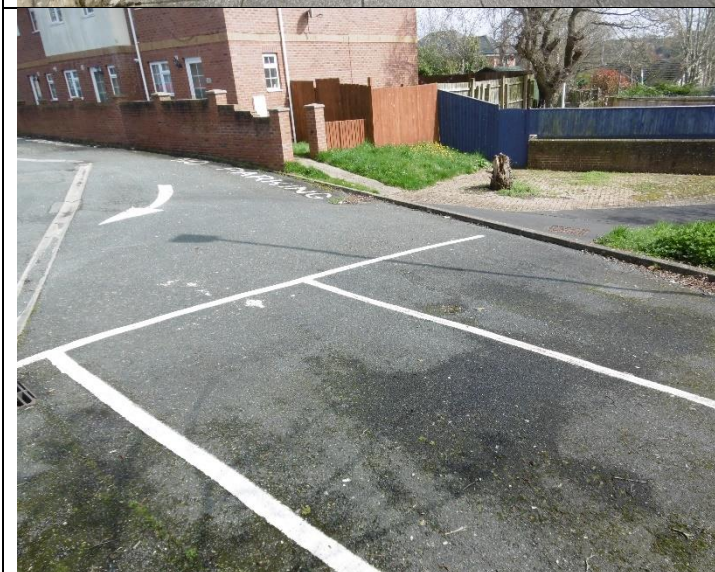
Brannon Way Car Park The footway on the right connects to the eastern end of Mary Rose Avenue with the car park and onwards to the village centre. The lack of dropped kerb restricts access.

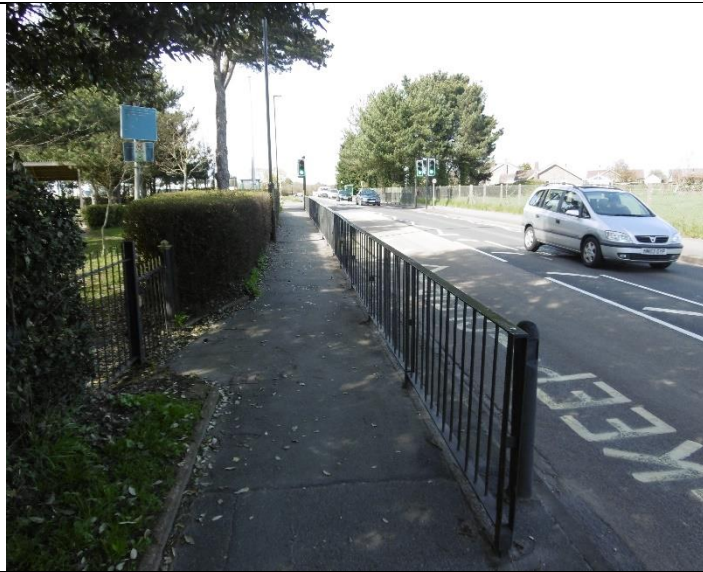
#### Whippingham Road

This long run of guardrail, present only on one side of the road, could trap pedestrians (crossing) or cyclists (riding along the carriageway). While this is a sensitive site outside a school, options should be investigated to allow removal of the guardrail and implementation of more active-travel friendly safety measures.

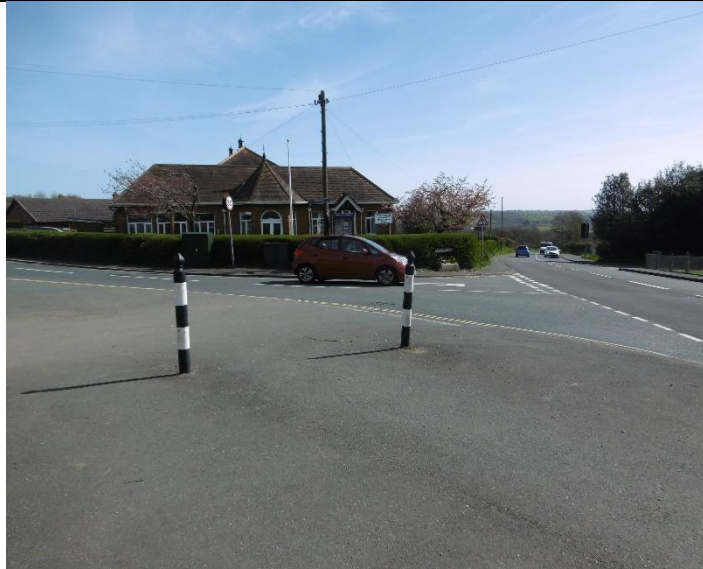
#### Alverstone Road

These bollards appear to be installed to prevent overrun/footway parking by vehicles accessing the forge. They present a collision risk for pedestrians, particularly those with visual impairments. An alternative layout with the introduction of a grass verge and clearly defined routes for pedestrians and vehicles access the forge may provide a better solution.

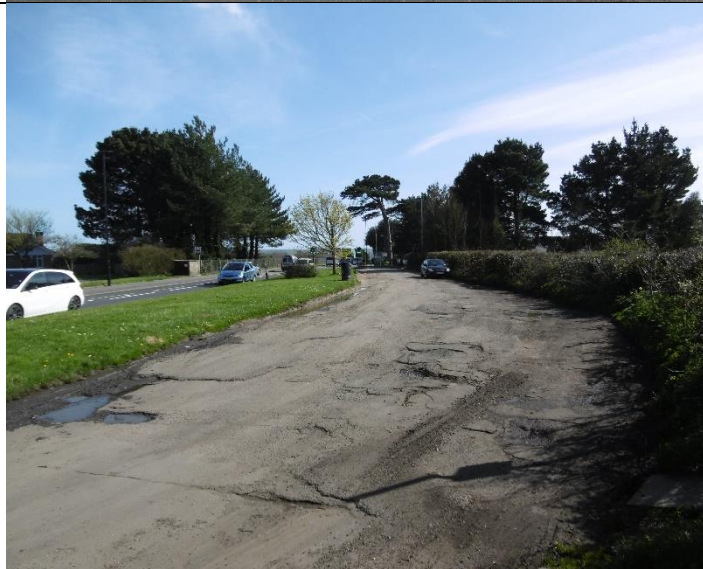
#### Whippingham Road

The footway ends at either side of layby with people forced to walk on the layby itself which provide a poor and unsafe environment. There are no dropped kerbs to allow through access for wheeled users. Creation of a continuous pedestrian route here is possible in various ways – through reallocation of space from the layby or creation of a footway on the current verge.

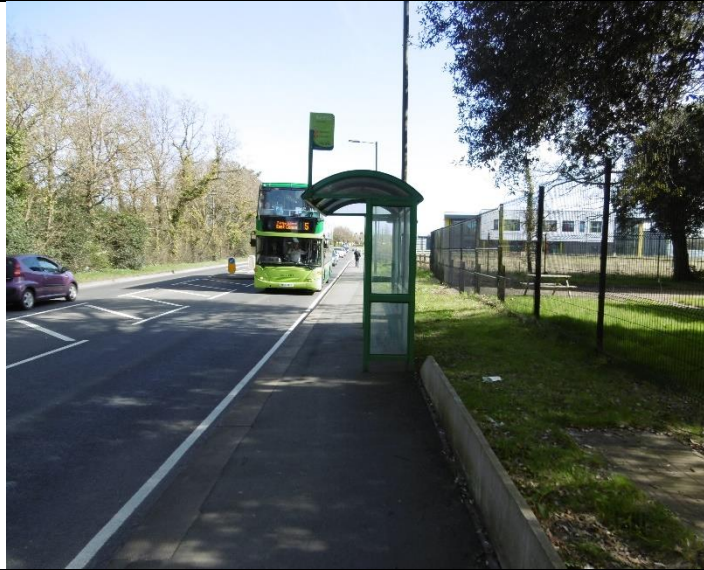
### Whippingham Road

This bus stop could be located in verge space to maintain footway width. It currently narrows the footway to 1.3m to the kerb edge, alongside a 40mph road.

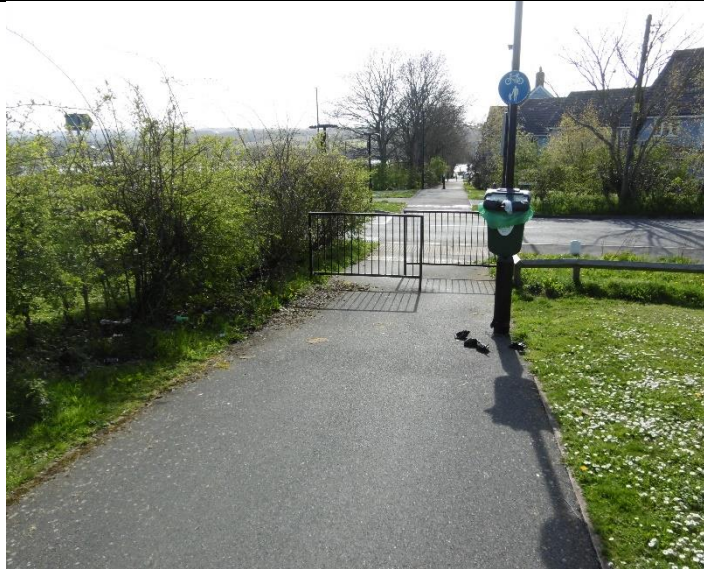
### Saunders Way

These chicane barriers are set 1.4m apart, with a gap of 1.2m from the path edge to barrier. This arrangement is inconvenient for all users and completely inaccessible for some types of cycle (modified cycles for disabled people, tandems, cycle trailers) and probably some mobility scooters.

These barriers do not comply with current guidance. Chicane barriers should only ever be used as a last resort and should never be as close together as these. The junction could almost certainly be laid out in a safe configuration without any need for barriers. There is sufficient space to curve the shared path on the approach to slow cyclists. Coupled with reduction of the hedge to improve visibility and creation of a raised crossing point to slow vehicles this would provide a vastly superior layout,

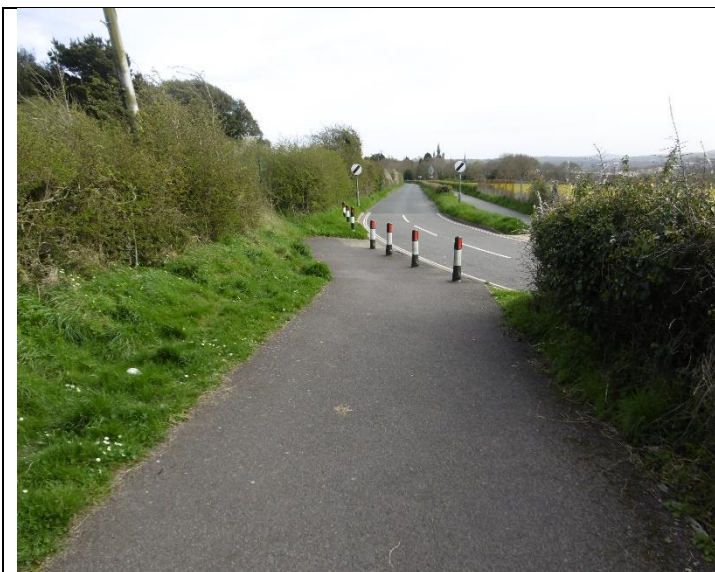
### Beatrice Avenue

These bollards partly obscure visibility of children and add to turn difficulty for cyclists. They appear unnecessary and could probably be removed. Consideration should be given to installing a raised table for the cycling and walking crossing to slow vehicles at this point.

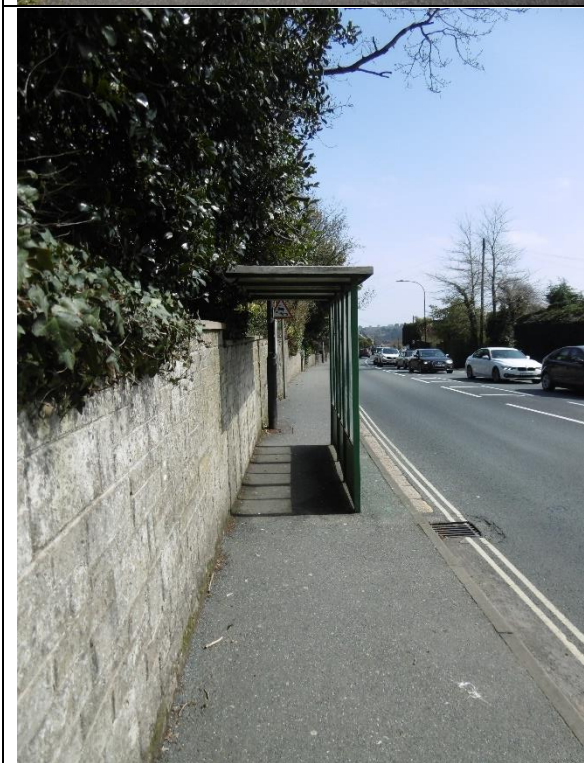
### High Street

The bus shelter narrows the footway width to 1.2m which provides inadequate width for pedestrians even without anyone waiting at the stop. Mounting the canopy on uprights at the back of the footway in line with the adjacent lamppost would maximise available footway width. In addition, the footway could be widened here with the removal of the right turn "half lane" for the tiny number of vehicles turning into Kennedy Close.

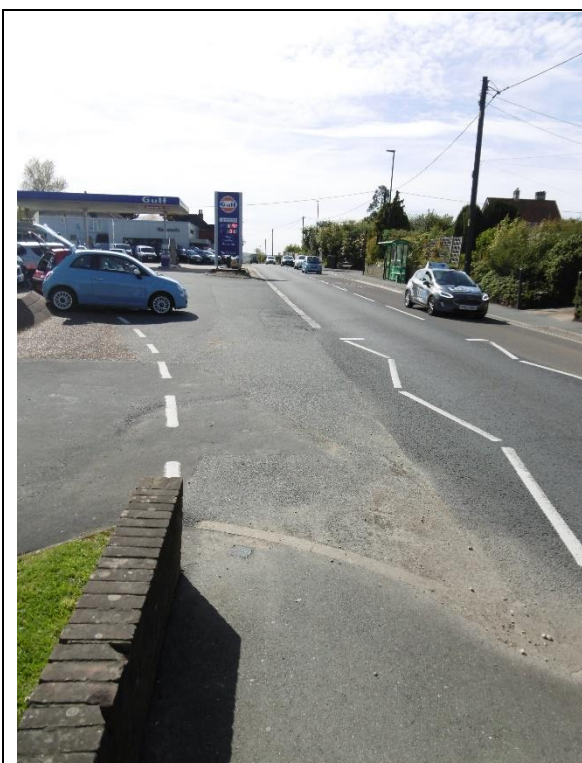
### High Street

At this point the footway disappears into the garage forecourt. The flush kerb gives no warning to visually impaired pedestrians. Ideally the footway should continue alongside the garage, however this is likely to require major redevelopment. As an interim measure warning tactile paving should be installed.

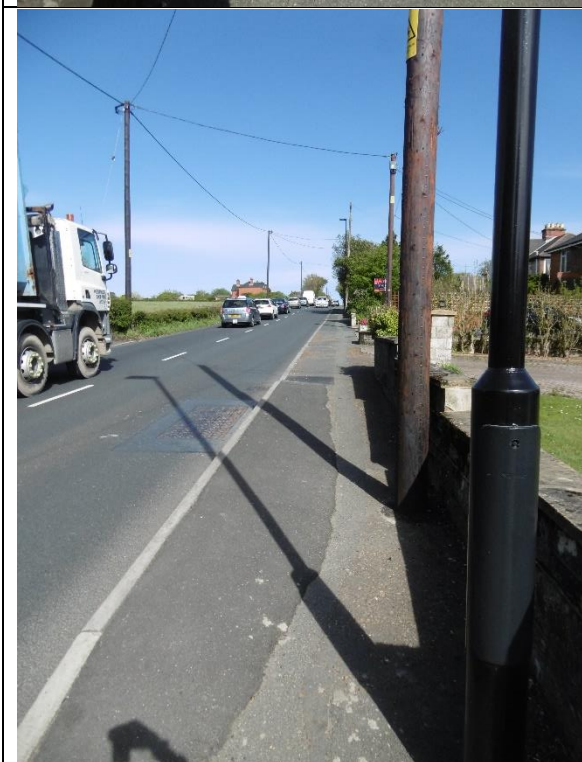
### Lusington Hill

There is a severe adverse camber to the footway here with huge variation in footway heights. This may be adjusted within the Island Roads upgrade programme but if not should be a target for remedial action.

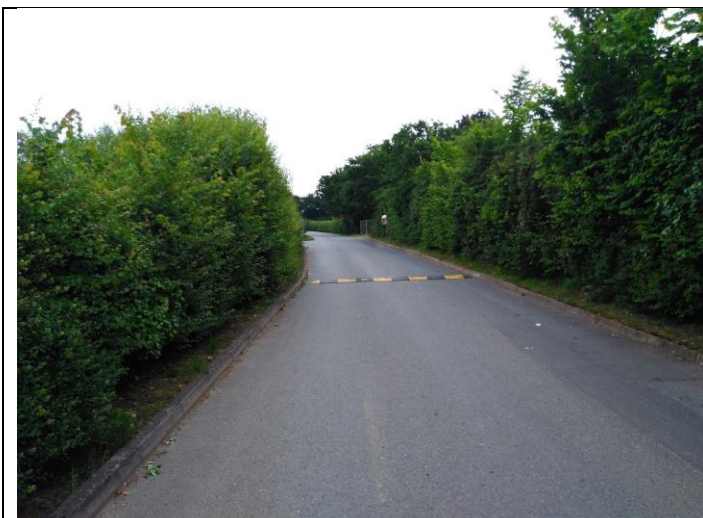
#### Mill Lane

Bolt-on speed humps across the full width of the lane provide an obstacle for wheeled users.

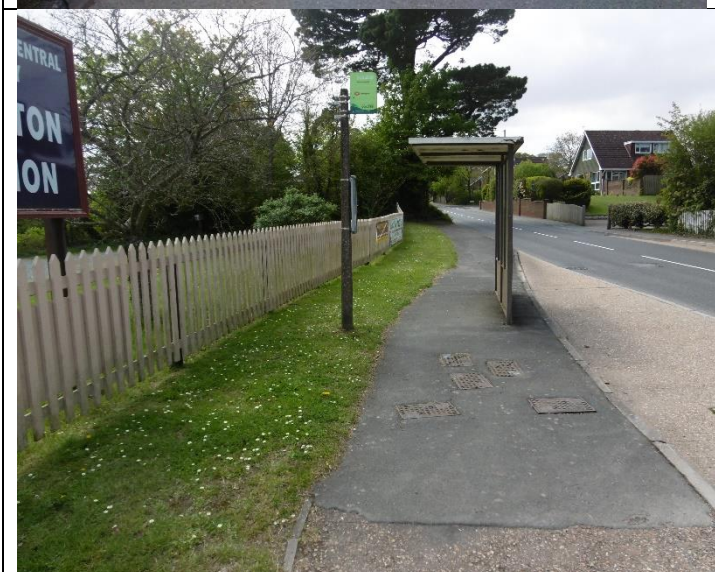
#### Station Road

The bus shelter could be relocated from the footway to the verge or by reducing the bay size.

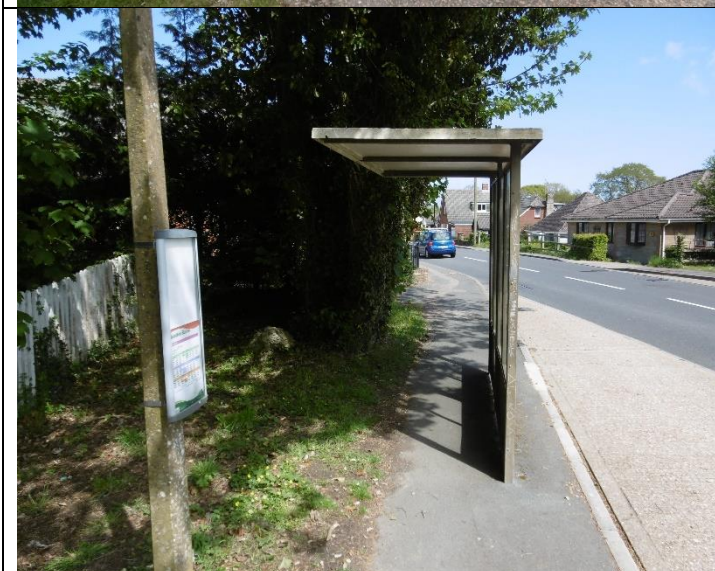
#### Station Road

The bus stop is in the middle of the footway, causing a significant obstruction. It could be relocated to the verge or by reducing the bay size.
