**Wootton Bridge & Whippingham**

# **Walking & Cycling Environment Report**

**June 2018**

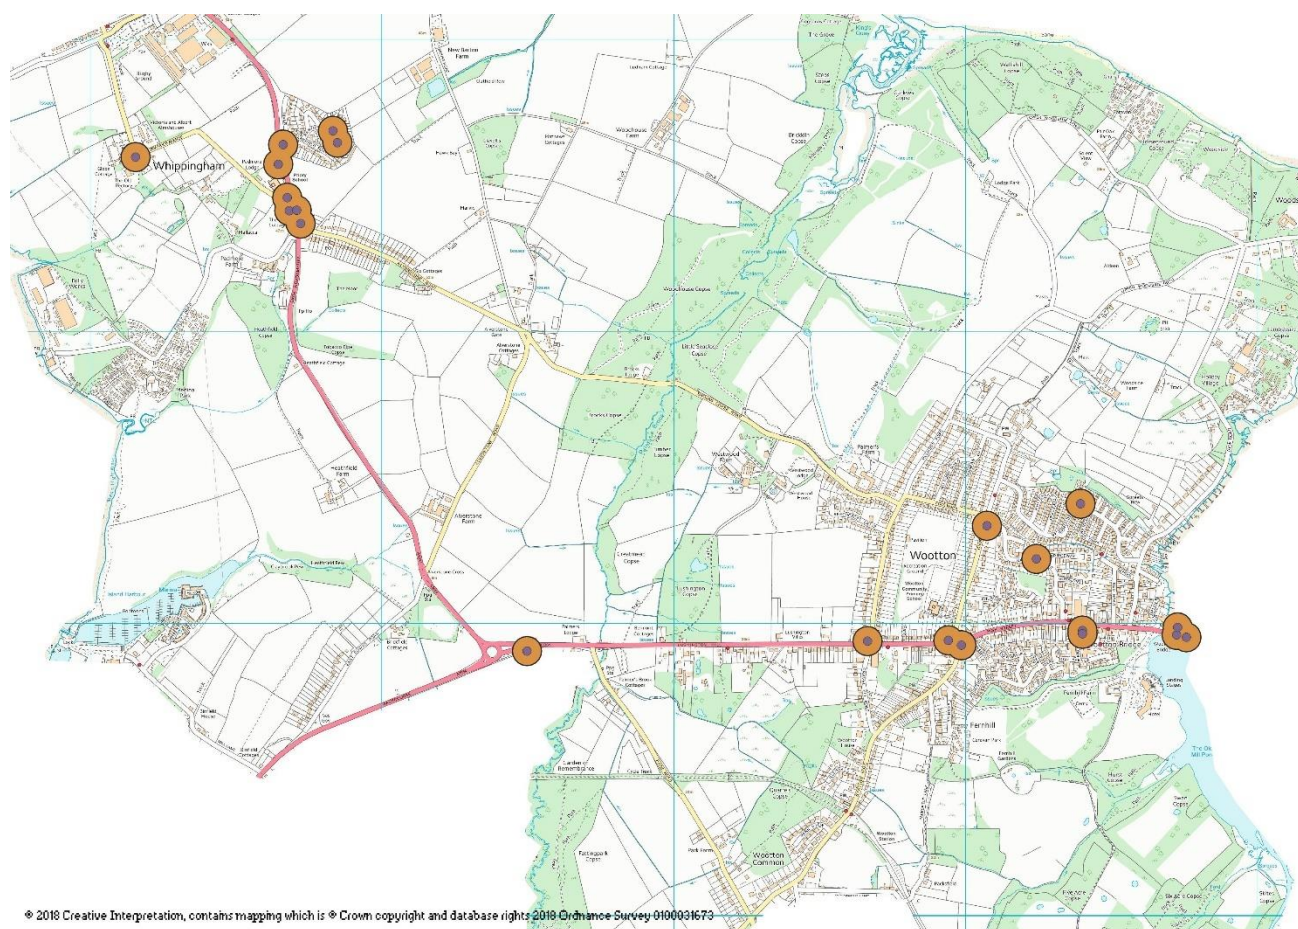
Figure 4 - Map showing seating locations with 50m buffer. Ideally the buffers should join together in main activity areas, indicating distances of no more than 100m between seating

Benches are provided in a number of areas throughout the two parishes, their locations are shown in Figure 4 - Map showing seating locations with 50m buffer. Ideally the buffers should join together in main activity areas, indicating distances of no more than 100m between seating. This map also shows a 50m radius around each. Where these circles join together it indicates seating opportunities are no more than 100m apart, which is a good starting point for a comprehensive network of seating to allow for different abilities to walk without a rest.

Whippingham has seating at frequent locations along Whippingham Road between Campfield Road and Alverstone Road, providing seating that is never much more than 100m apart along this section, including at each bus stop on both sides of the road.

In Wootton Bridge there are several benches, but distances between them are often much higher even in the centre and along main walking routes and there are no benches at or close to most bus stops. Some bus stops have small areas of “perch” seating, but even this is not provided at some key stops.

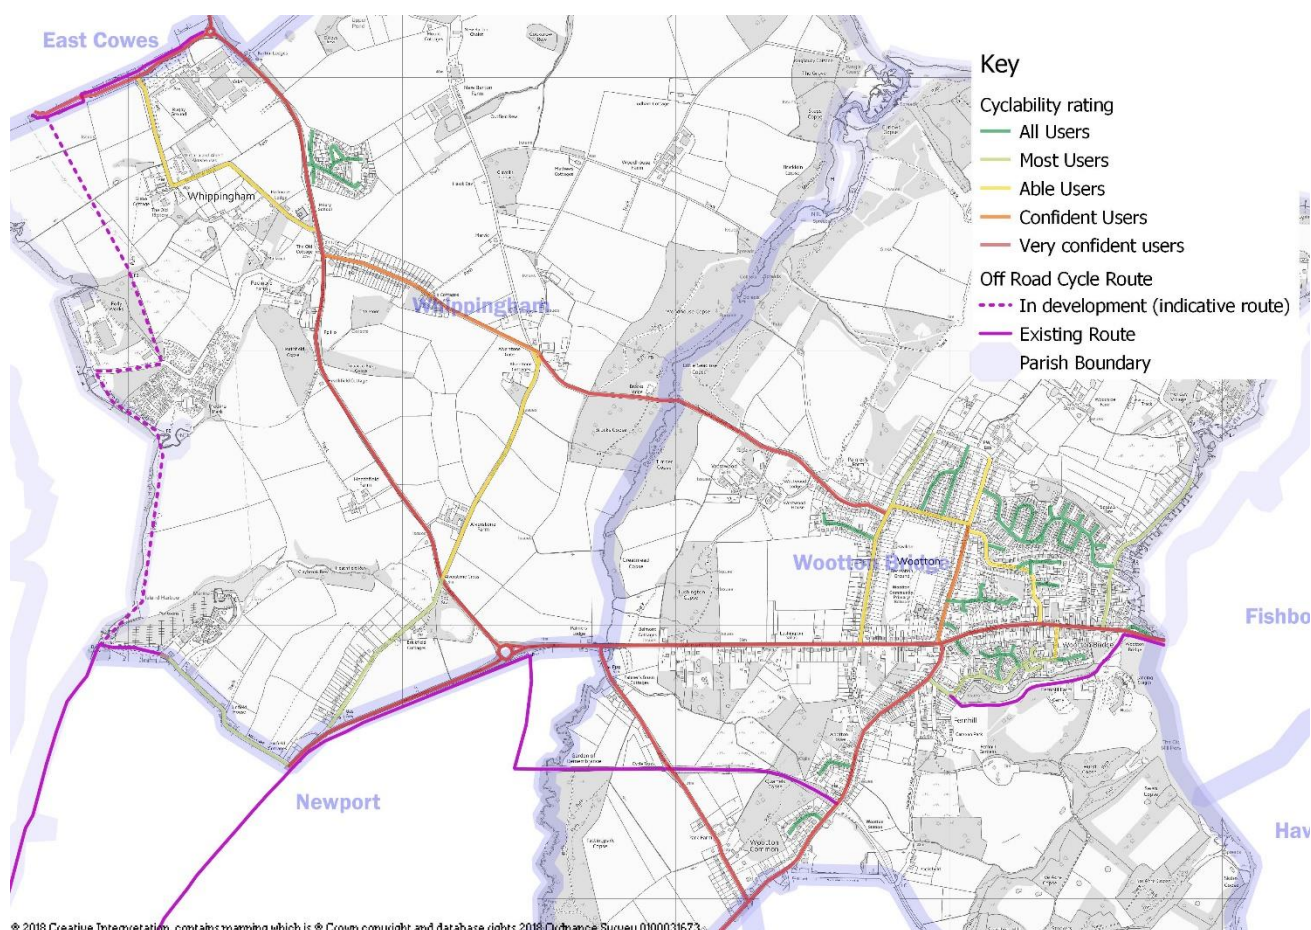
Figure 5 - Map showing cyclability rating of streets and off-road network

The map below shows the results of the cyclability ranking for adopted roads in the parishes. CycleWight have produced a dataset using the same methodology for the Newport parish area which may assist planning networks across the border. To make cycling safe and attractive for all ages, from schoolchildren to pensioners, and abilities it is important to create a comprehensive network of easily cyclable roads (green) and off road /protected cycleways (purple).
